Influence of Surface Contamination on the Electrical Breakdown between Ag Electrodes in AC Plasma Display Panels

In this study, the surface contamination and related electrical current were examined by TOF-SIMS and Micromanipulators in order to identify the main factors on the electrical short phenomenon between Ag electrodes in the 50-in. full HD AC-PDPs with a various contaminations. The experimental results reveals that such atoms as Na, K, and Cl were detected on both Ag electrode and glass surface as culprits causing sever surface contamination. It was also found that the more severely contaminated the samples were, the more increased the electrical current became. This result confirms that the electric breakdown on the Ag electrode is closely related with its surface contamination.

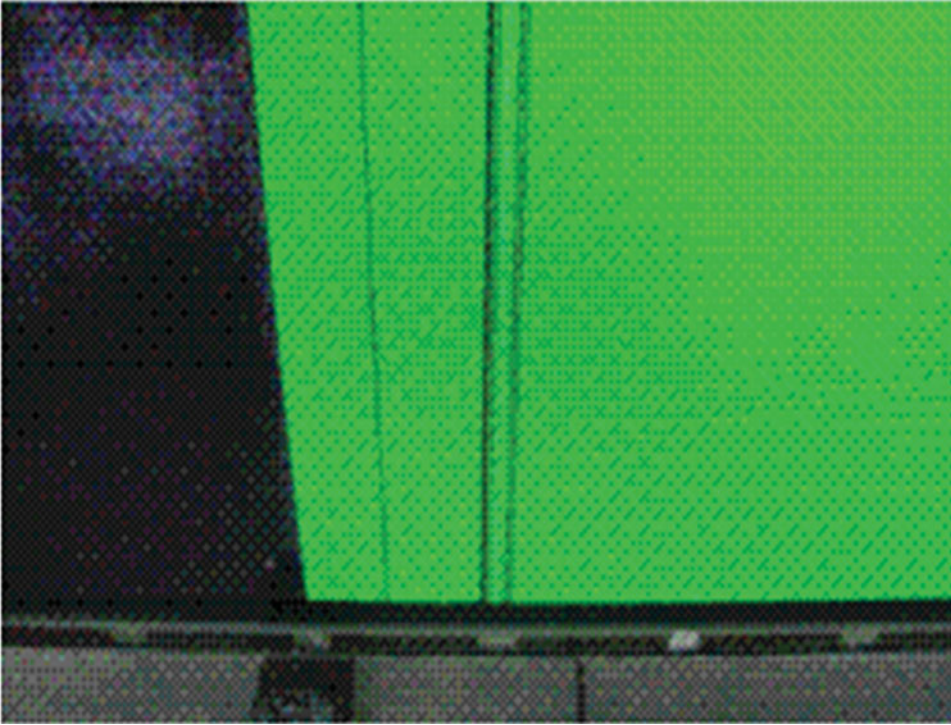
Figure 1. Ag electrode short phenomenon of the full-HD PDP module.

The Ag electrode short phenomenon was indicated in the 50'' full-HD PDP module as shown in Fig. 1. In this case, it is a severe failure in mass production line. In order to solve the main reason about this problem and prevent the failure in advance, we try to investigate various experimental tools.

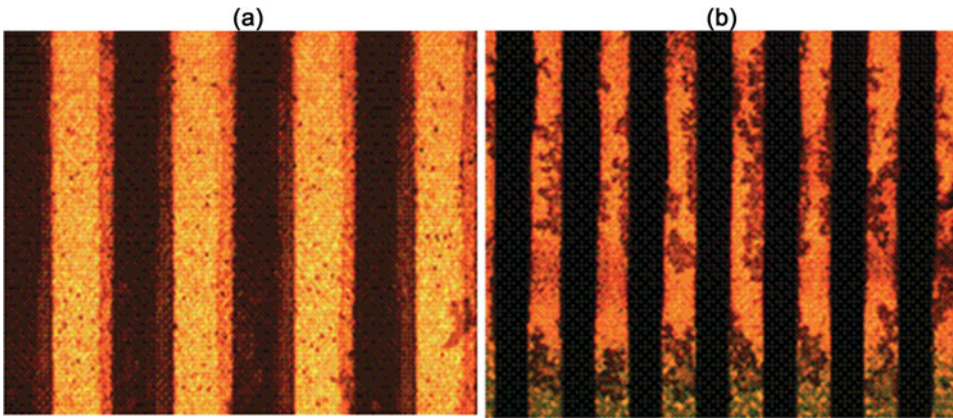
Figure 2. (a) Clean and (b) contaminated surface in the optical microscope.

Figure 2(a) clean and 2(b) contaminated surface in the optical microscope.

Figure 3 contaminated surface in FE-SEM image on the electrical short phenomenon with contamination. From these results in Figs. 2(a), (b) and 3, there are some surface contamination, such as carbon, hydro-carbon, Na.

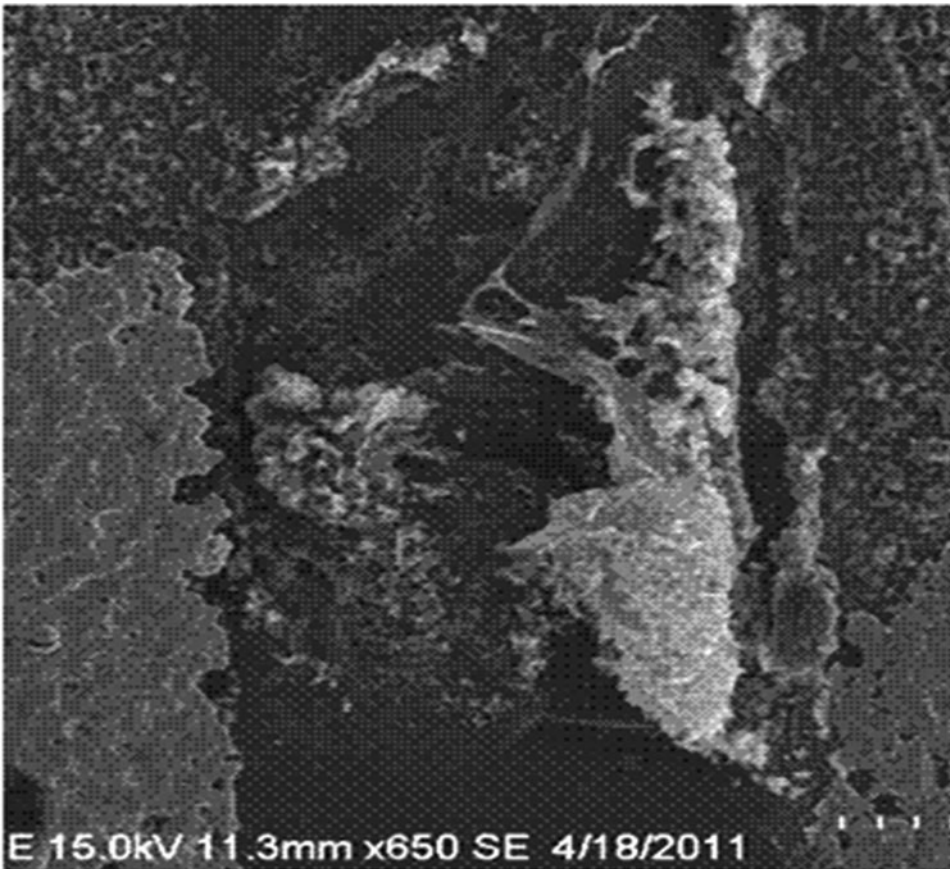
Figure 3. Contaminated surface in FE-SEM image on the electrical short phenomenon with contamination.

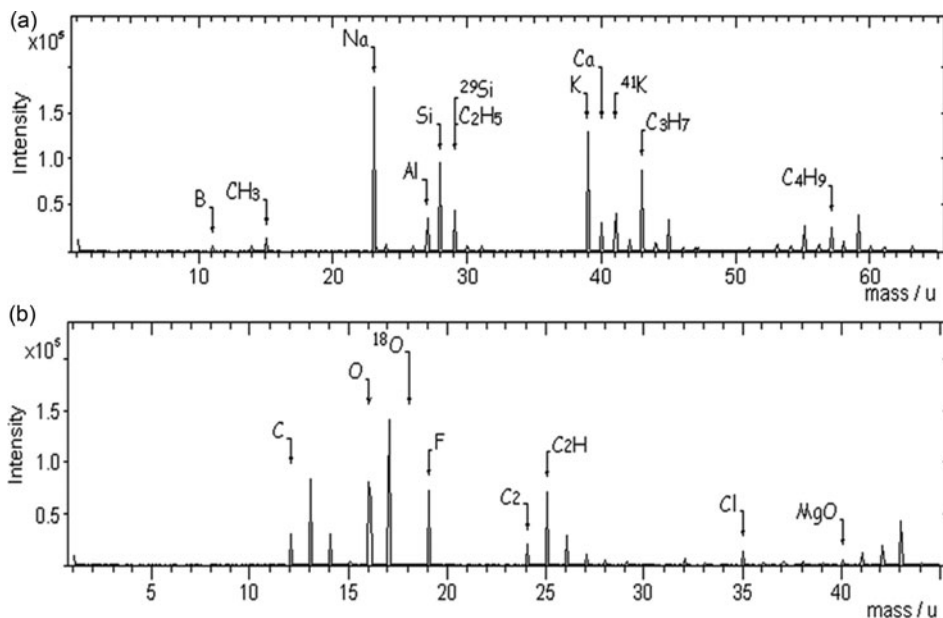
Figure 4. TOF-SIMS (a) positive and (b) negative mass spectra between Ag electrode and glass, in case of the surface contamination.

In order to identify about contamination in detail, The TOF-SIMS 4(a) positive and 4(b) negative mass spectra between Ag electrode and glass with respect to various contamination conditions. The measured TOF-SIMS data showed that the contamination elements such as Na, K, Cl, C, and hydrocarbon were detected between the glass surface and Ag electrodes. Figure 5 shows the TOF-SIMS image with respect to contamination elements. The contaminated surface has higher Na, K elements than without surface contamination, thereby inducing a conductive path, such as AgCl, KCl, and NaCl between Ag electrode and glass, under proper temperature and humidity conditions according to physical reaction.

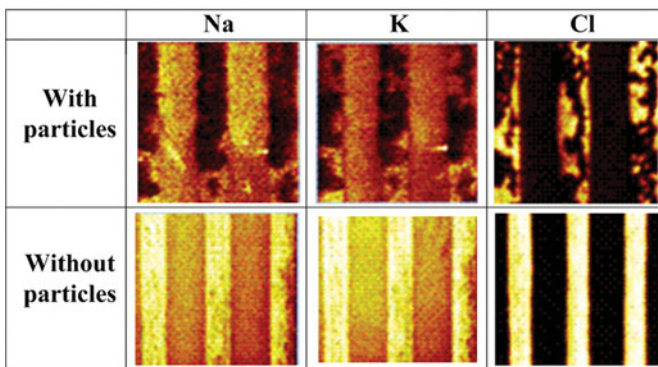
Figure 5. TOF-SIMS image of the Ag electrode and glass surface with respect to contamination conditions.

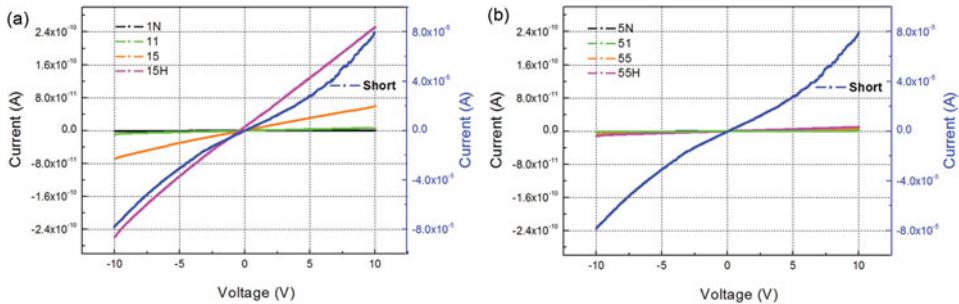
Figure 6. Current-voltage (I-V) curve (a) with and (b) without contamination.

Figure 6(a) shows the characteristics of current-voltage in full-HD PDP panel in case of contamination particles. There is a few current change without particles as shown in Fig. 6(a). However the Fig. 6(b) represents that as the voltage is applied between Ag electrodes without particles, there is no electrical current with a various contamination conditions. The experimental results reveals that such atoms as Na, K, Ca, and Cl were mainly detected on both Ag electrode and glass surface as culprits causing sever surface contamination. It was also found that the more severely contaminated the samples were, the more increased the electrical current became. This result confirms that the electric breakdown on the Ag electrode is closely related with its surface contamination.
